INSPECTION REPORT

For the Property at:
325 S. SANTA
CLAUS LANE NORTH POLE, AK 99705

Prepared for: SANTA CLAUS
Inspection Date: Sunday, March 1, 2020
Prepared by: Yevgeny Govshievich

RE: Report No. 2356
325 S. Santa
Claus Lane North Pole, AK
99705

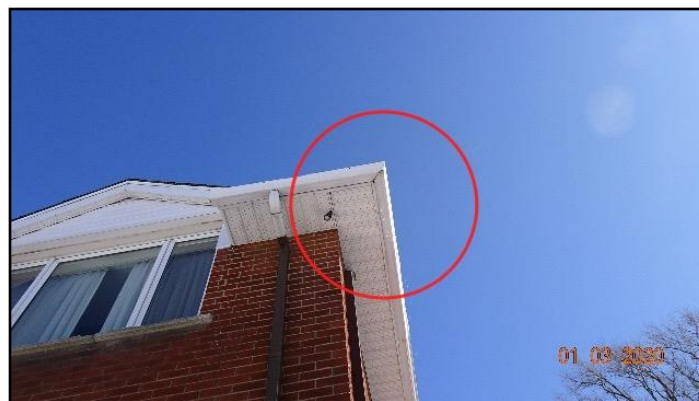
2. Leak

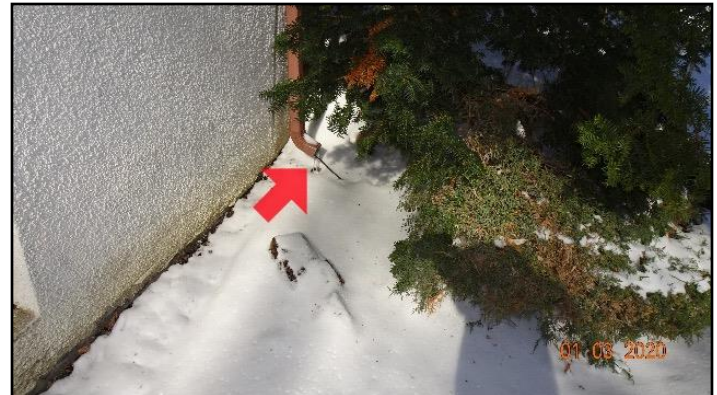
3. Should discharge 6 feet from building

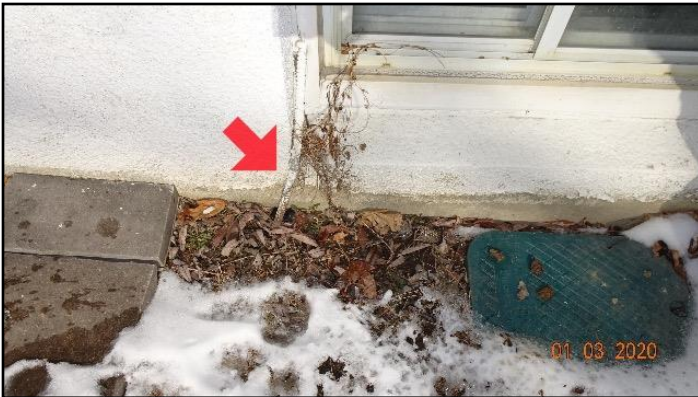
5. Crack

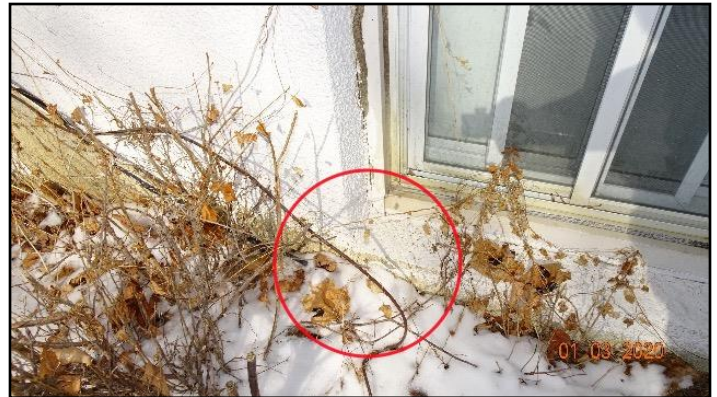
6. Crack

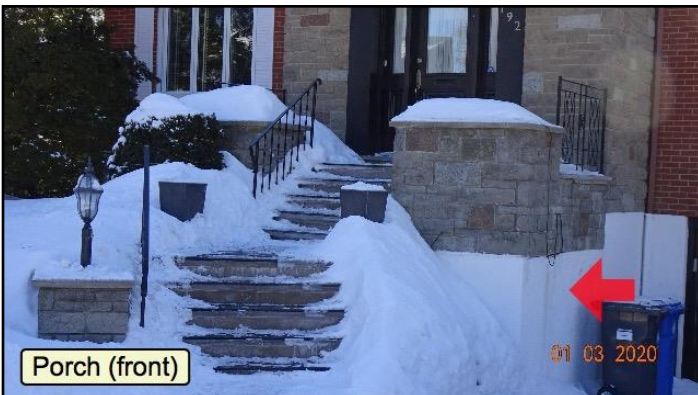
7. Moisture penetration

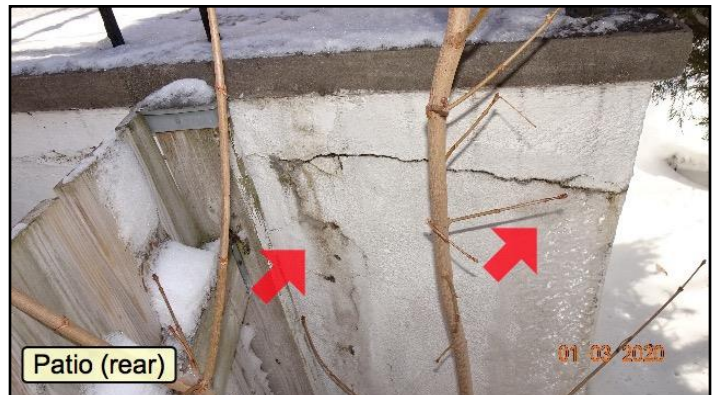
8. Moisture penetration

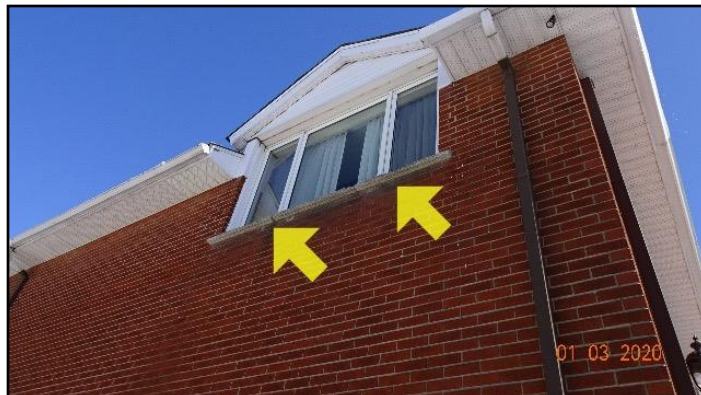
9. Sill deteriorated

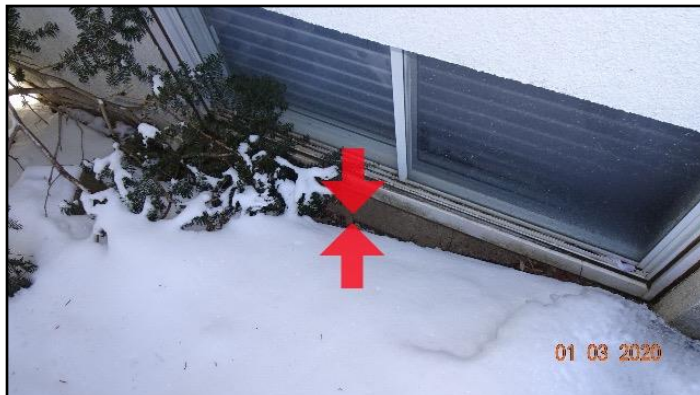
10. Missing window well

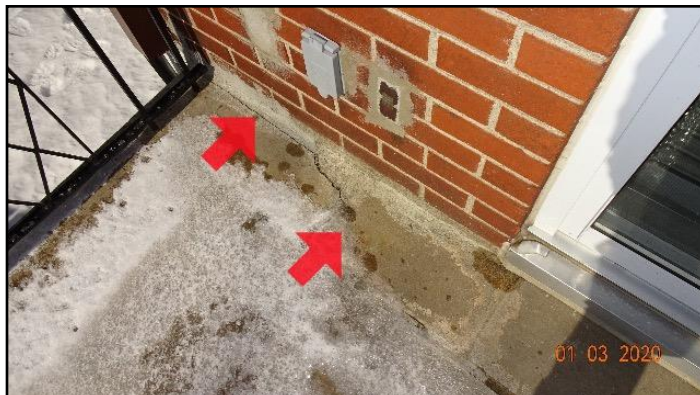
11. Cracked floor

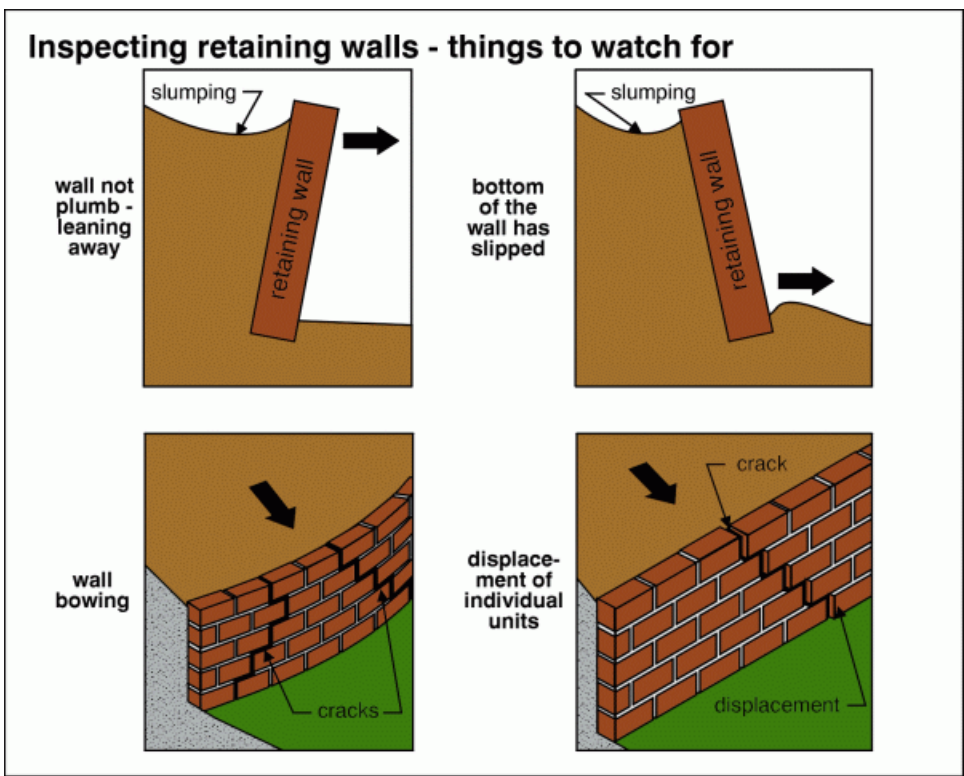
12. Leaning wall

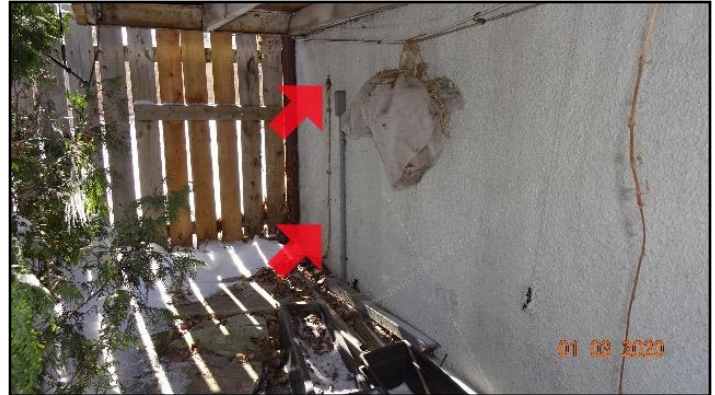
18. Wire not protected

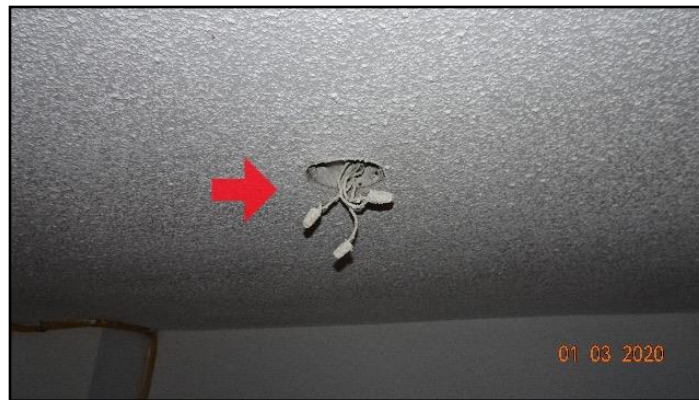
19. Cover missing

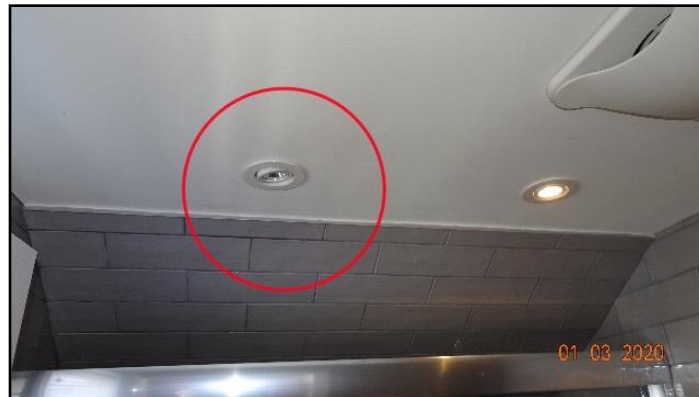
20. Inoperative

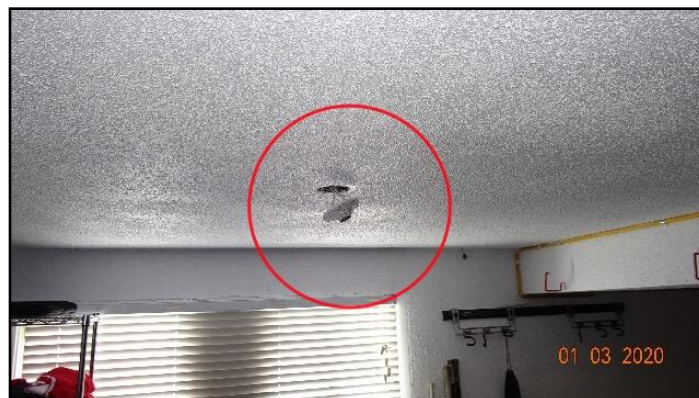
21. Loose

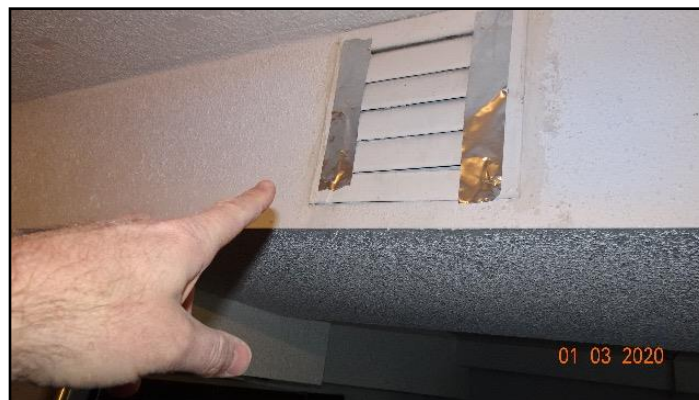
28. Registers or grilles in garage

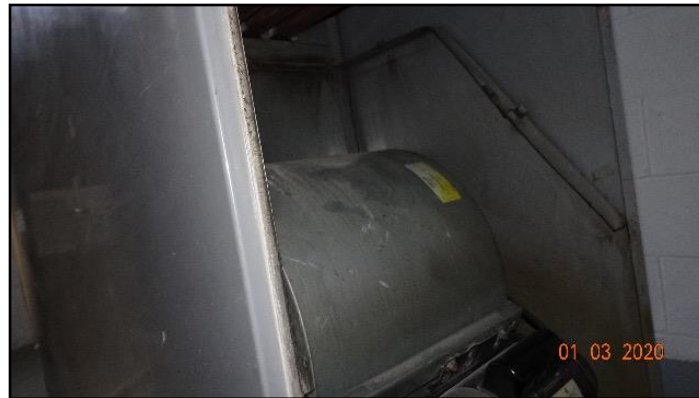
29. Missing filter

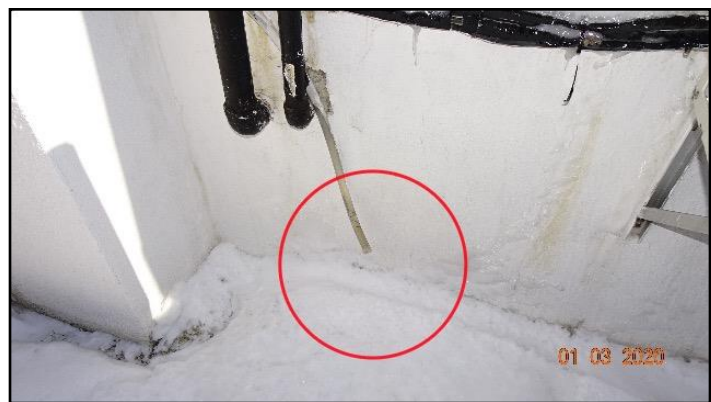
33. Improper discharge point

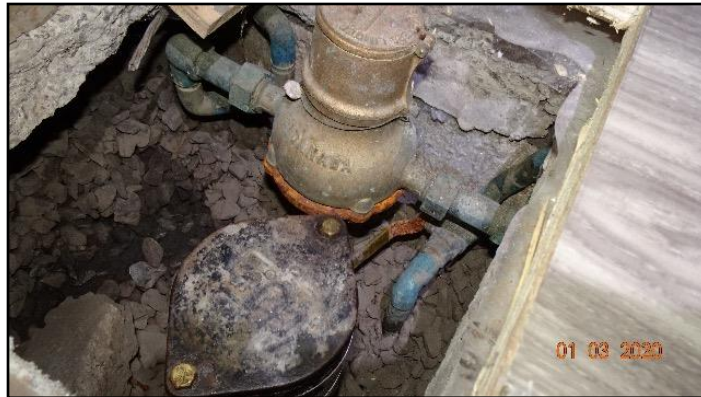
39. No seal on water meter

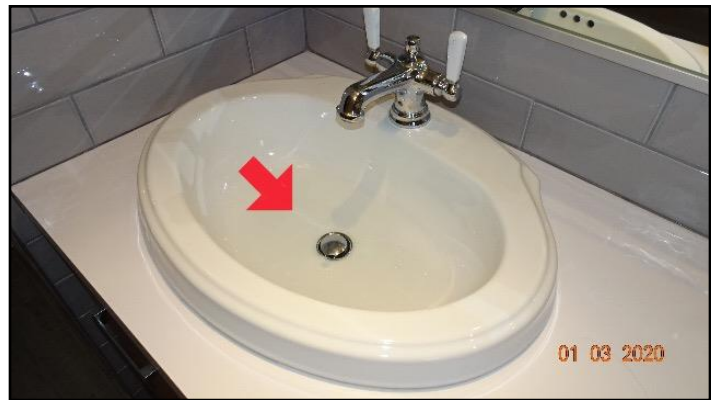
40. *Slow drains*

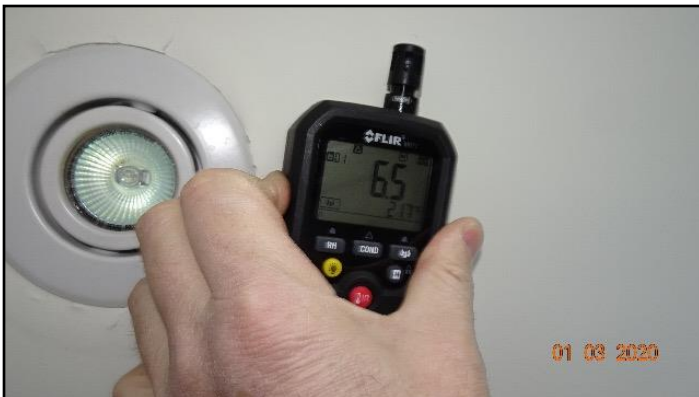
42. Moisture meter reading

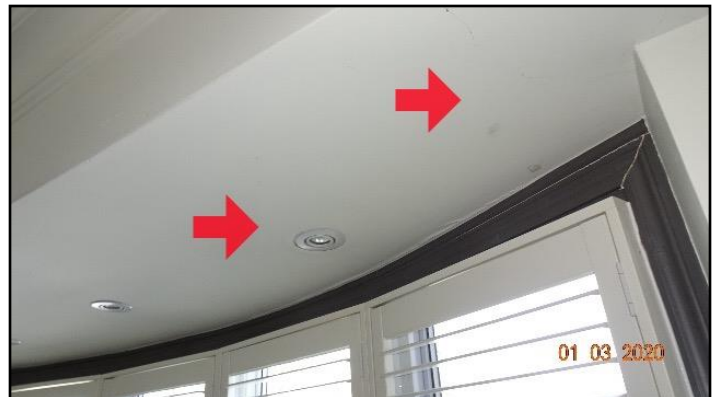
43. Water damage

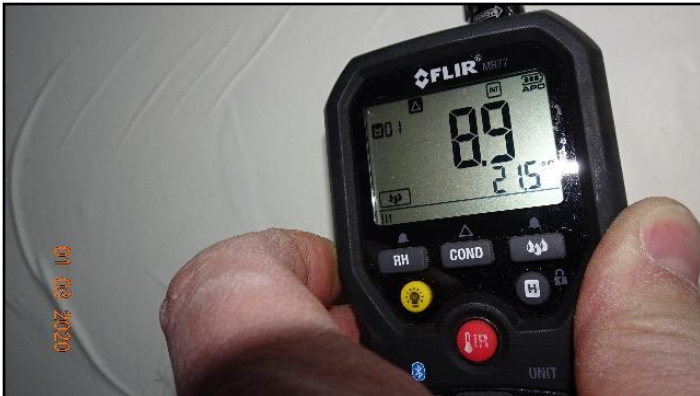
44. Moisture meter reading

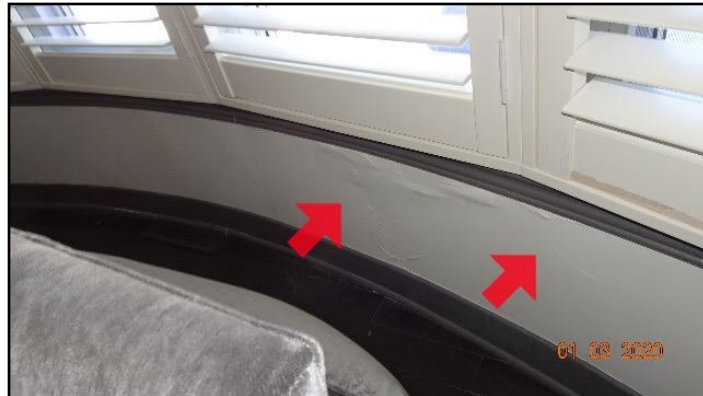
45. Water damage

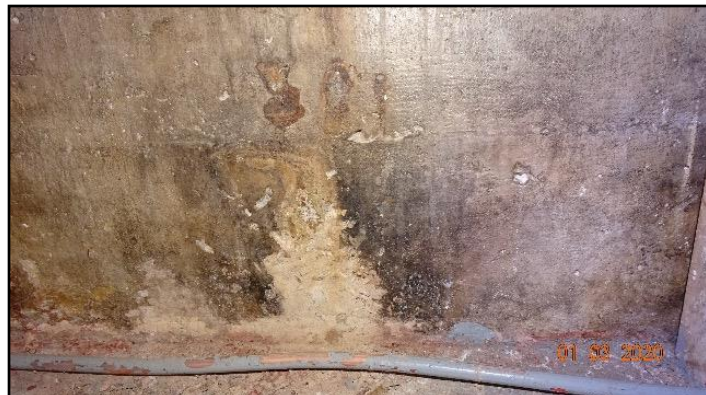
47. Mold

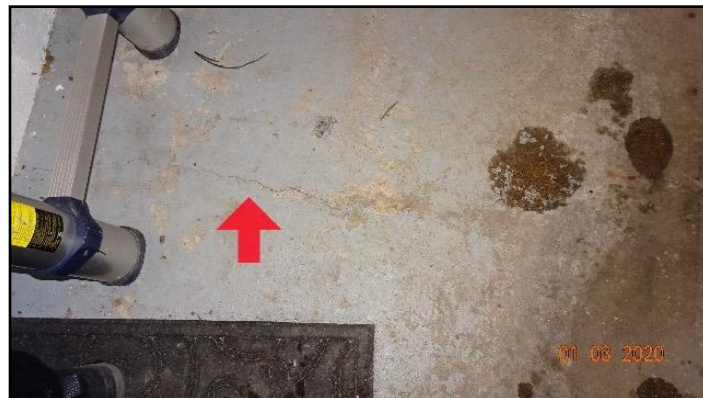
49. Cracked floor

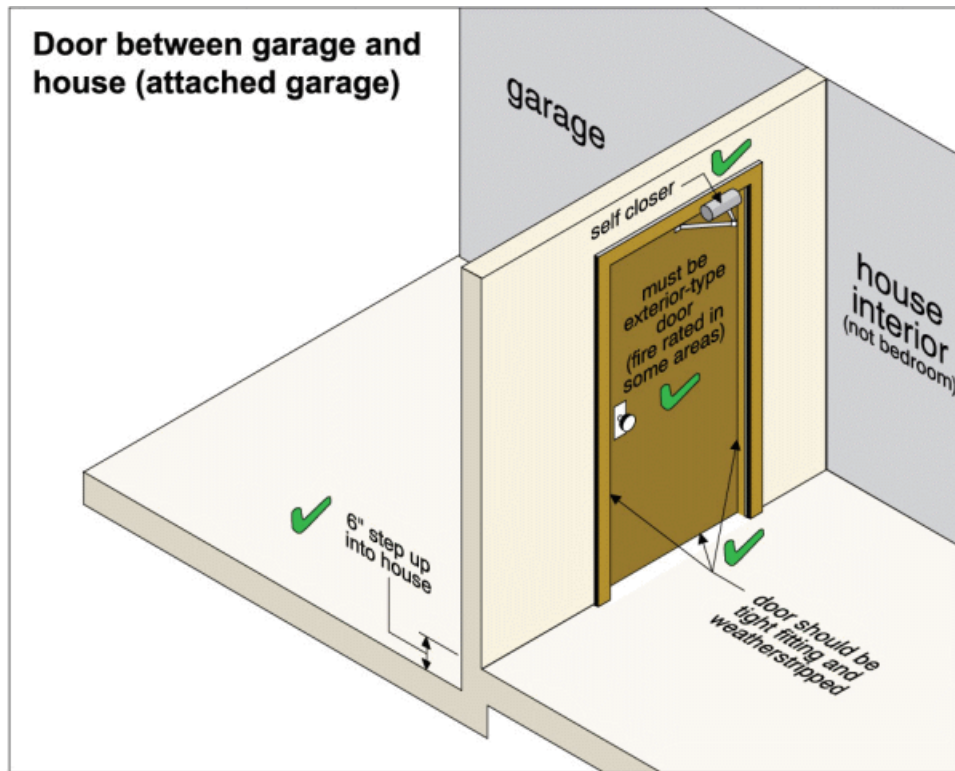
50. No self closer

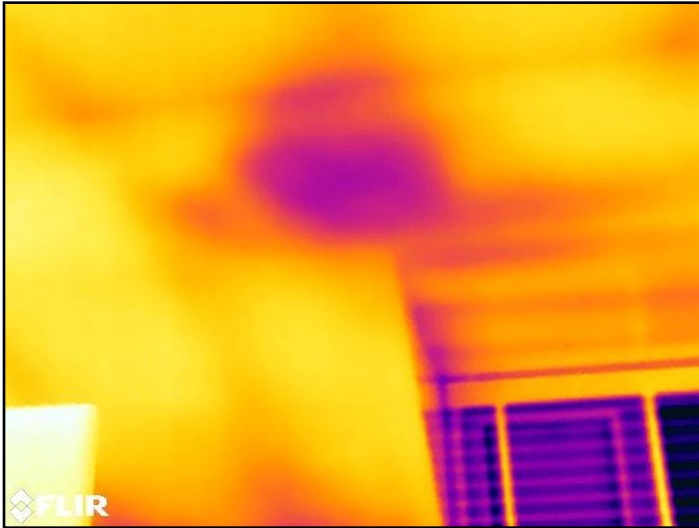
51. Voids (IR VIEW)

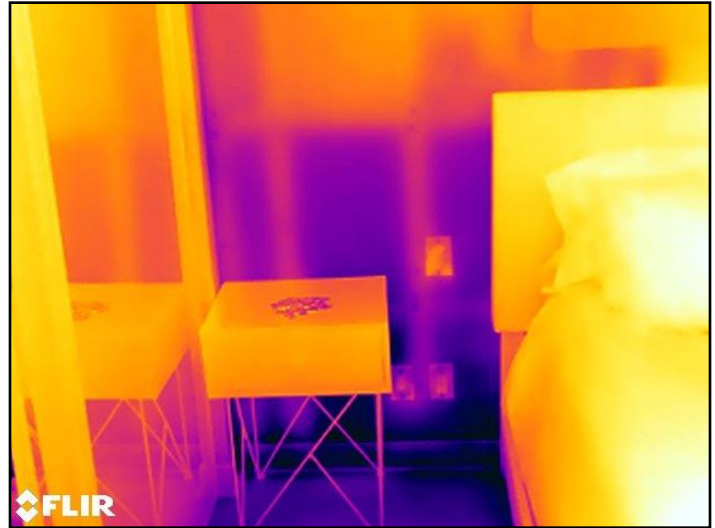
52. Voids (IR VIEW)

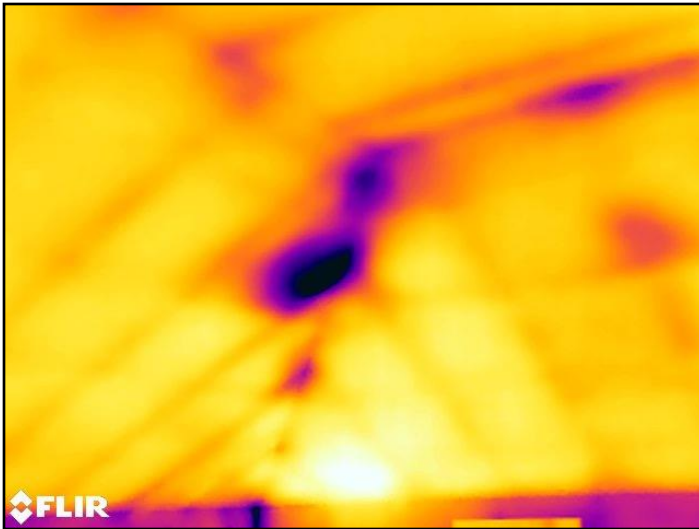
53. Voids (IR VIEW)

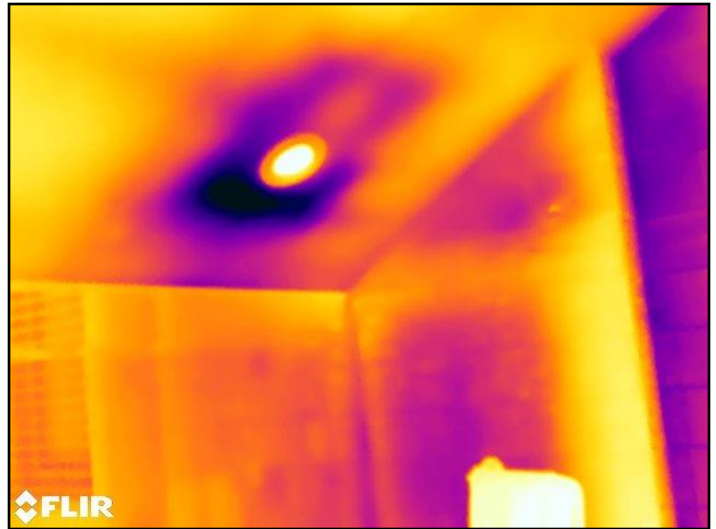
54. Voids (IR VIEW)

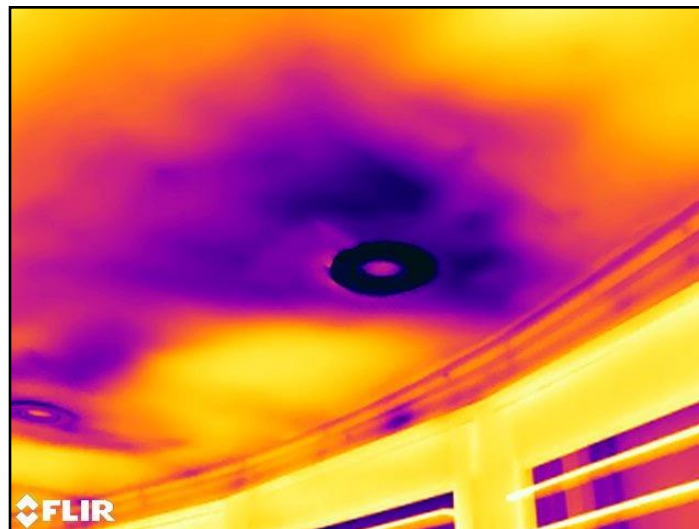
55. Voids (IR VIEW)

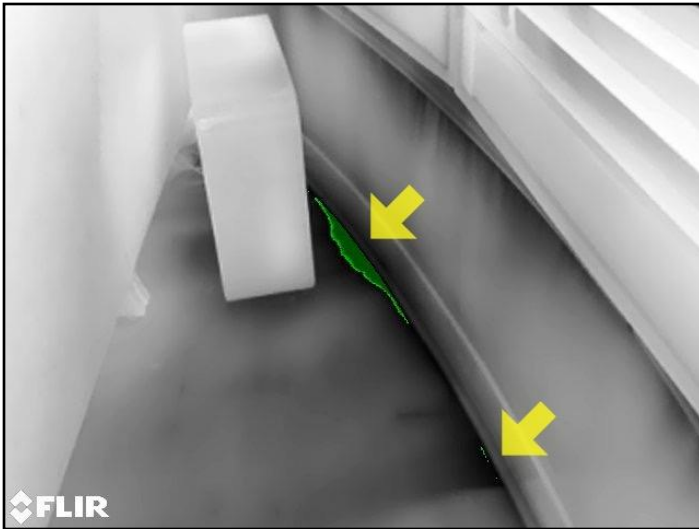
56. Condensation alarm (IR VIEW)

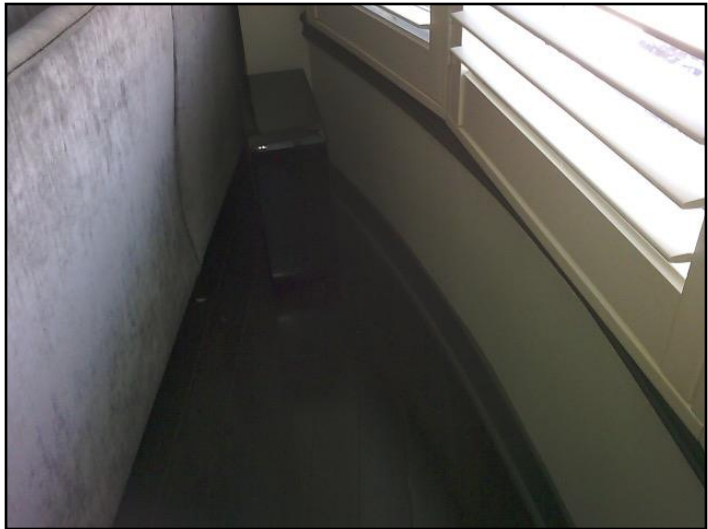
57. Condensation alarm
