INSPECTION REPORT

For the Property at:
325 S. SANTA
CLAUS LANE NORTH POLE, AK 99705

Prepared for: SANTA CLAUS
Inspection Date: Sunday, March 1, 2020
Prepared by: Yevgeny Govshievich

RE: Report No. 2356
325 S. Santa
Claus Lane North Pole, AK
99705

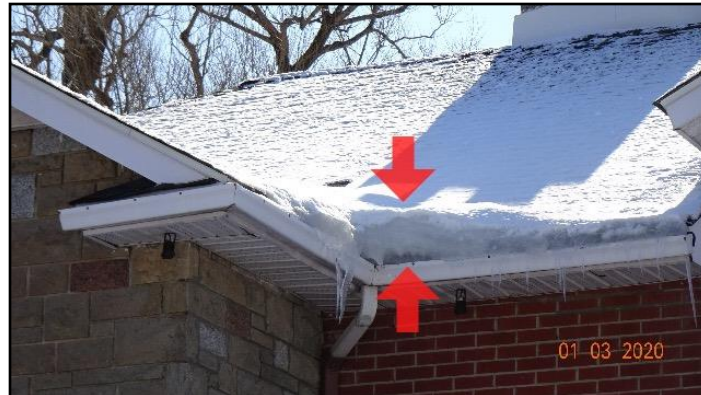
Condition: • [Vulnerable to ice damming](#)

The best way to prevent ice dams from forming is to address the three factors in your attic that contribute to ice dams; insulation, ventilation, and attic air leaks. Attic air leaks (or attic bypasses) is the largest contributor to ice dams. Attic bypasses such as air leakage through incomplete or unsealed vapour barriers & exhaust vents venting into the attic are passageways for warm house air to enter in to the attic space; traditional insulation won't fix this. The best approach to air sealing and insulating is to add 2 inches of closed cell polyurethane foam insulation on the attic floor and blown in fibreglass or cellulose insulation overtop to achieve the current standards for insulation values.

1. *Vulnerable to ice damming*

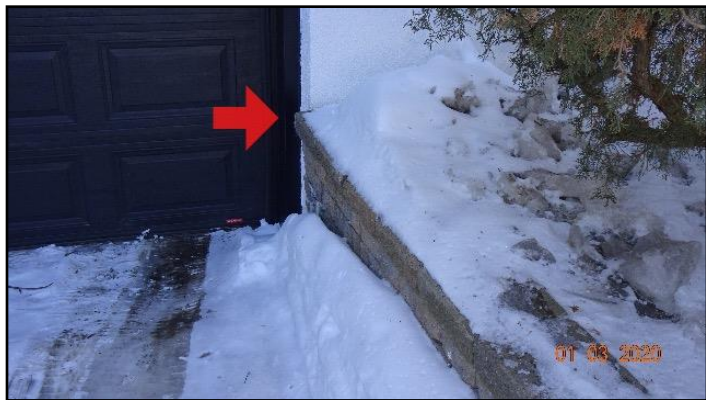
Condition: • [Leaning](#)

12. Leaning wall

Task: Repair

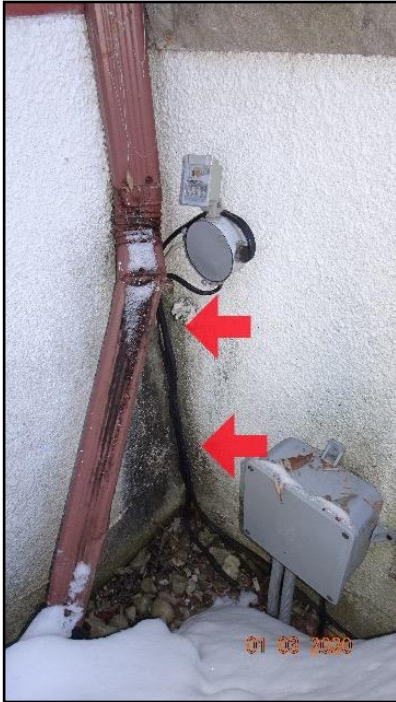
Condition: • Wire not protected

Implication(s): Electric shock, Fire hazard

17. Wire not protected

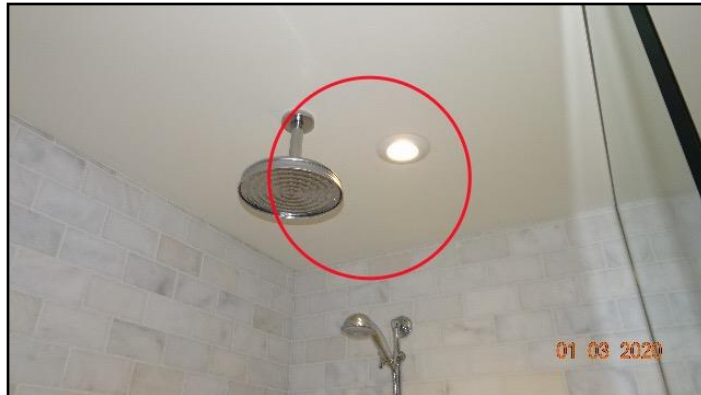
Condition: • [Conventional lights in wet areas](#)

Implication(s): Electric shock | Fire hazard

22. Conventional lights in wet areas

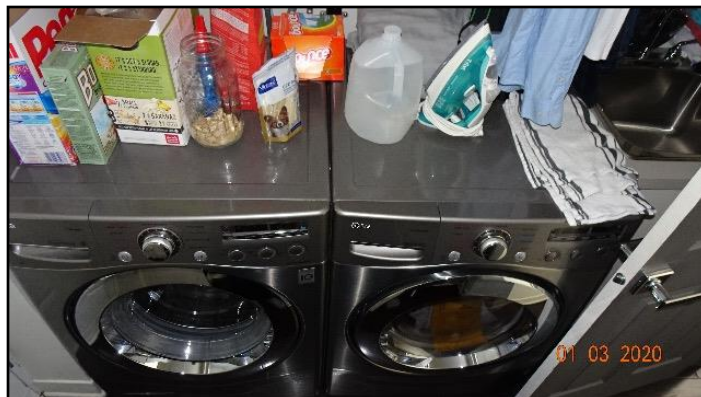
41. Laundry facilities

- Laundry facilities

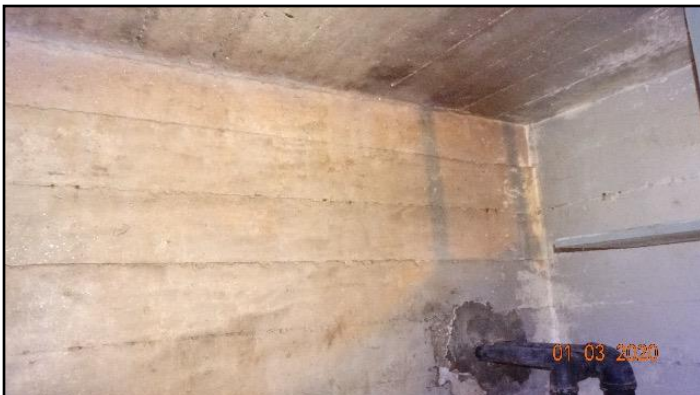
46. Mold

72. Condition: • Mold

Note: Air test for mold recommended Please refer to the "Recommendations" partition of the EXTERIOR sections of the report.

Air test for mold recommended

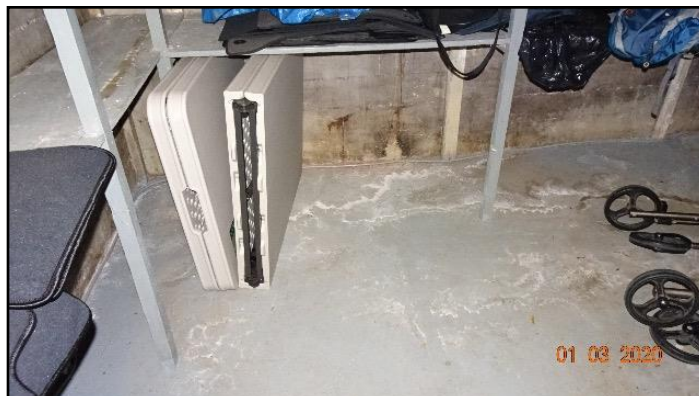
48. Water mark

74. Condition: • Water mark

Implication(s): Chance of water damage to contents, finishes and/or structure

Task: Further evaluation (Consult specialist)

Time: Immediate

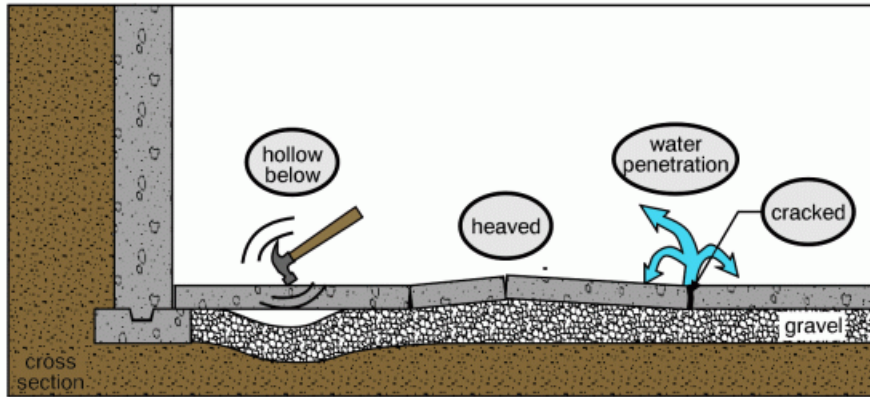
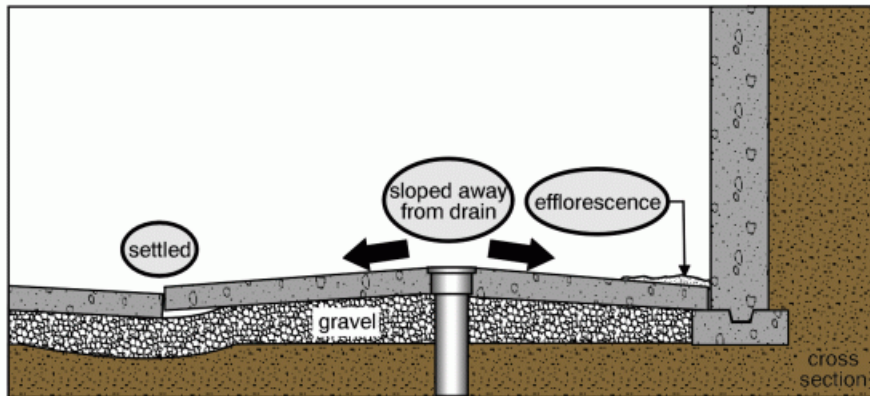
49. Cracked floor

75. Condition: • [Cracked](#)

Task: Repair

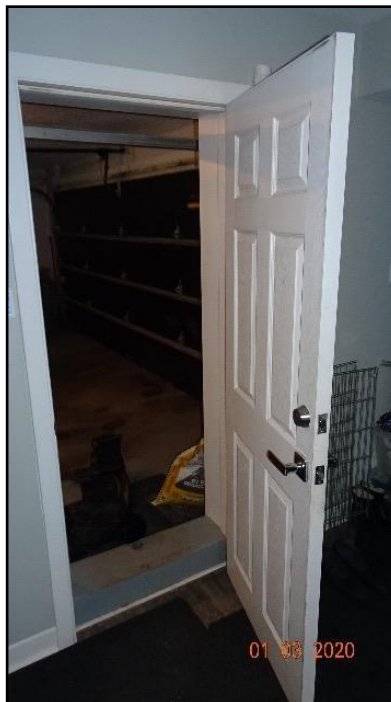
50. No self closer

76. Condition: • [No self closer](#)

Implication(s): Hazardous combustion products entering home

Time: Immediate
